ASBESTOS RE-INSPECTION SURVEY REPORT

WAREHOUSE 4
GSA BUILDING NUMBER WA0823KF
2509 C STREET SW
AUBURN, WASHINGTON

ASSESSMENT DATE:
09-14- 2012

PREPARED BY:
UNITED STATES PUBLIC HEALTH SERVICE
FEDERAL OCCUPATIONAL HEALTH SERVICE
DALLAS AREA OFFICE
1301 YOUNG STREET, SUITE 772
DALLAS, TX 75202

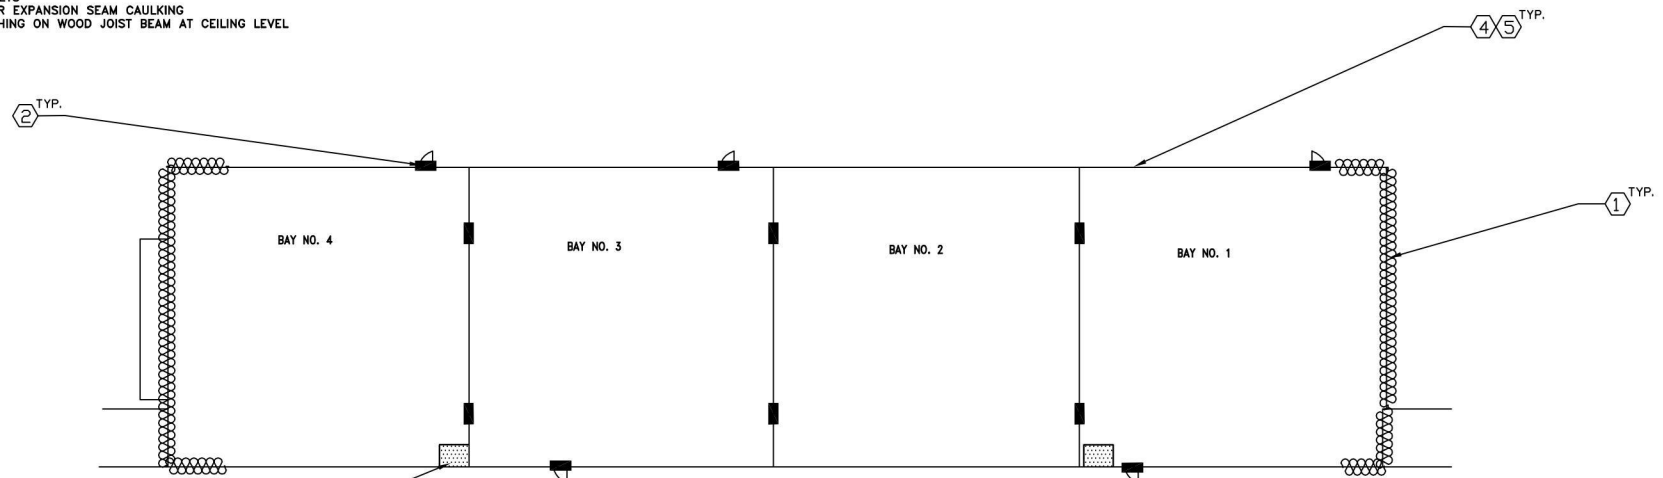
HM - 1.0

- CEMENT ASBESTOS BOARD EXTERIOR SIDING AND ASSUMED ASBESTOS CONTAINING FELT VAPOR BARRIER PAPER.
- ASBESTOS CONTAINING CORE FIRE DOORS. INTERNAL FIRE DOORS SEPARATE BAYS AND ARE APPROXIMATELY 10'X20' EACH.
- VINYL ASBESTOS TILE AND ASBESTOS CONTAINING MASTIC ON CONCRETE
- ASBESTOS CONTAINING ROOFING AND FELT VAPOR BARRIER
- CEMENT ASBESTOS DRAIN PIPES ON ROOF

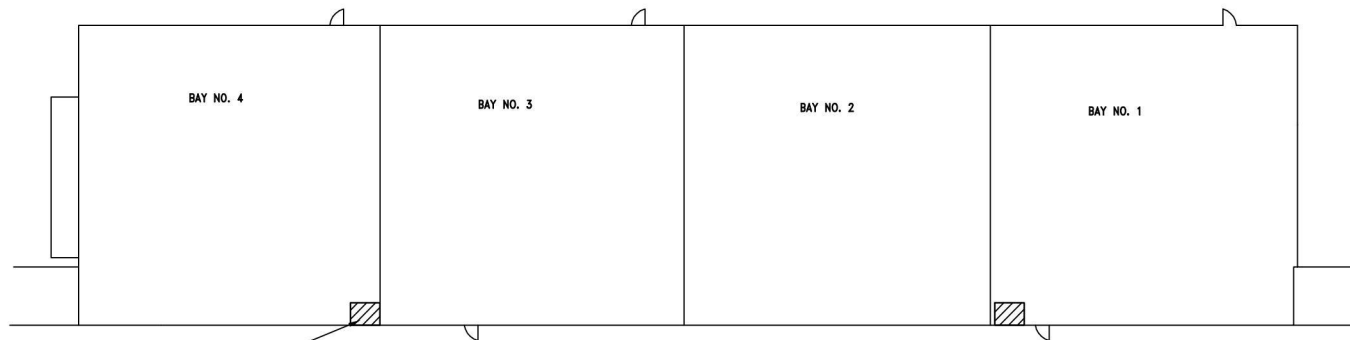
HM - 2.0

- ① ASBESTOS CONTAINING TSI PIPING (INCLUDES FITTINGS)
